**BULLETIN No. 510**

**TIMBER STORAGE CONDITIONS IN THE EASTERN AND SOUTHERN STATES WITH REFERENCE TO DECAY PROBLEMS.**

By C. J. HUMPHREY, *Pathologist, Office of Investigations in Forest Pathology.*

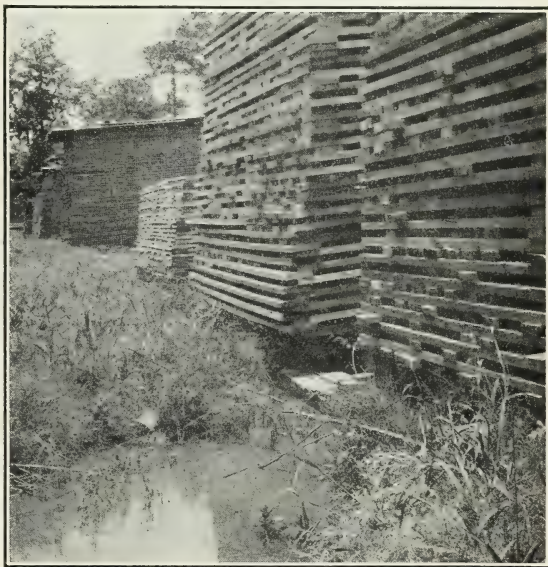
FIG. 4.—Lumber piled on low swampy land at a Texas sawmill. The serious decay in this yard is due to the excess of soil moisture and poor circulation beneath the stacks.

Where it is necessary to store lumber upon low swampy ground (figs. 4 and 5), the weed problem also becomes a serious factor. In the first place the growth of vegetation is so luxuriant as to require constant attention, and in the second place the ground is not even or firm enough to allow convenient mowing. The result is that sometimes the weeds are allowed to develop above the height of the foundations, thus cutting off air circulation beneath the piles and hence increasing the danger from fungi many fold.

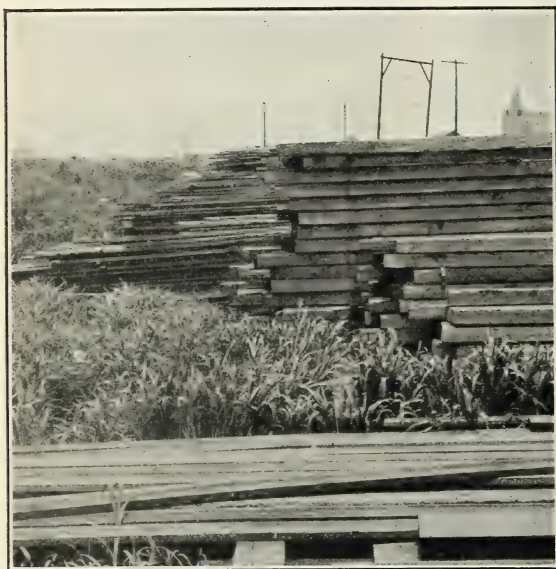
FIG. 5.—Pine lumber piled in a swamp on high skids over standing water at New Orleans, La. Note the luxuriant vegetation, which checks proper air circulation beneath the piles.

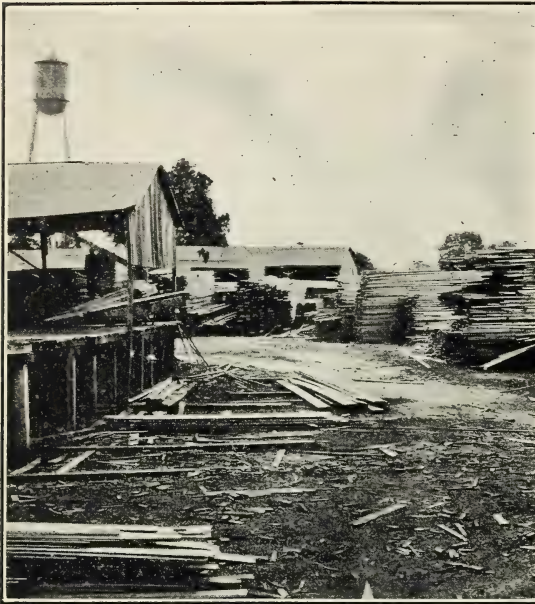
FIG. 7.—A small, very insanitary mill in Louisiana. The conditions at this mill are a disgrace to the lumber industry. Note the rotten, dilapidated tramway, the lumber stacks placed within 2 to 4 inches of the ground, and the debris scattered about and breeding infection.

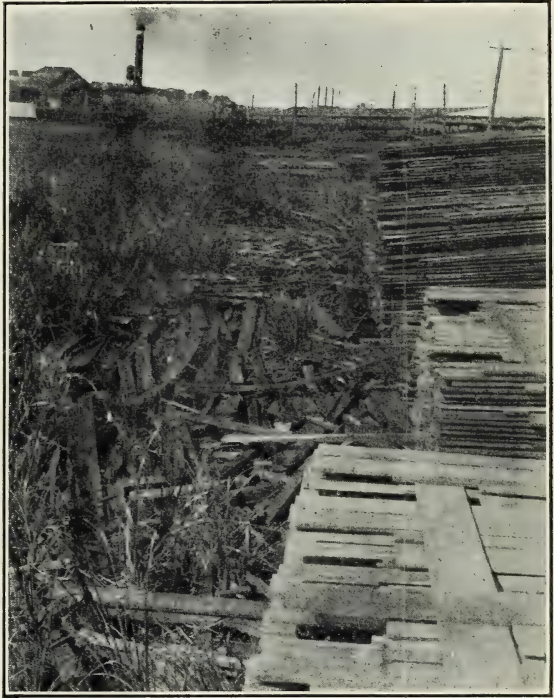
FIG. 9.—Pine and hardwood lumber which has rotted in storage in the yard shown in figure 11. Instead of burning the débris it was thrown into an adjoining rice swamp. Fungi developing on this débris will again infect the sound lumber.

Any decaying timber which has been allowed to accumulate about the yards should be collected and burned. The mere carting of such debris to a convenient near-by pile (Pl. III, fig. 1; text fig. 9) is not sufficient, for the fungi will continue to thrive in such material for long periods and to produce fruit bodies which will liberate millions upon millions of spores into

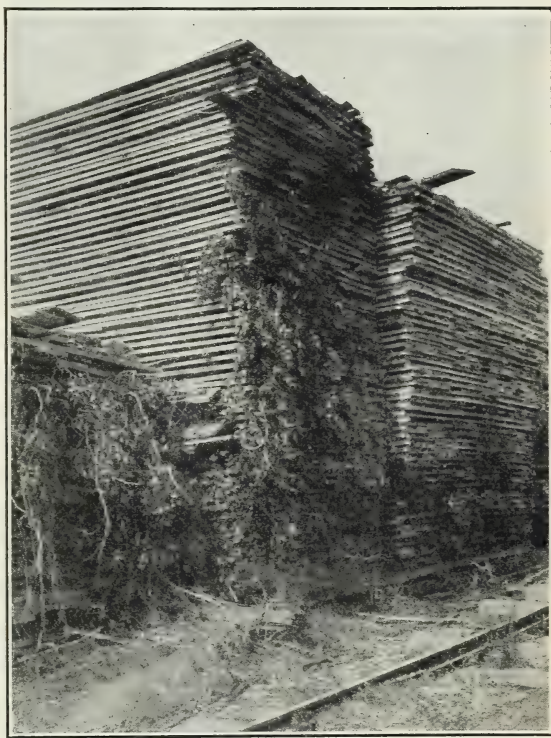
FIG. 13.—Vines growing over lumber piles. From a pathological standpoint this condition should be condemned, because the dense foliage prevents the lumber from rapidly drying out after rains, thus promoting decay.

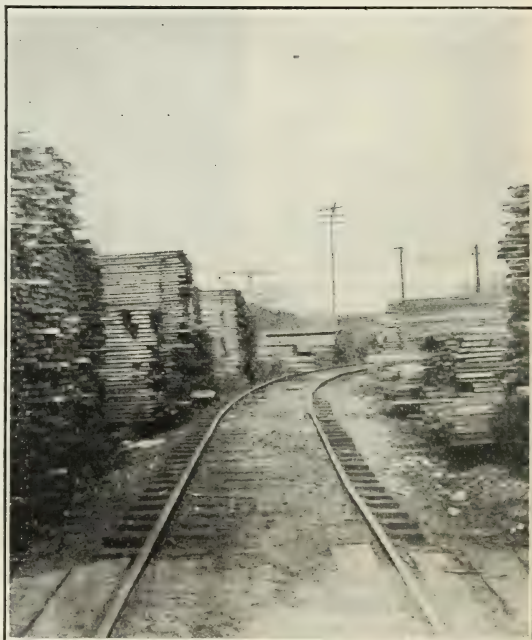
FIG. 15.—A clean, sanitary retail yard, having concrete foundations throughout and creosoted ties in the railroad track.

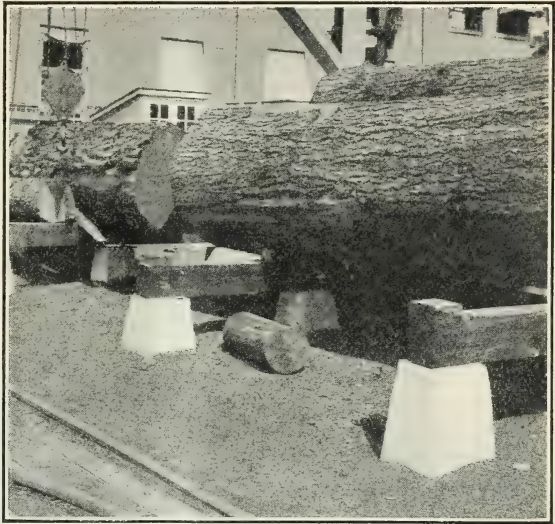
FIG. 18.—Pile foundations consisting of creosoted timbers resting on concrete piers in use at the Forest Products Laboratory, Madison, Wis. This is a very satisfactory type of foundation.

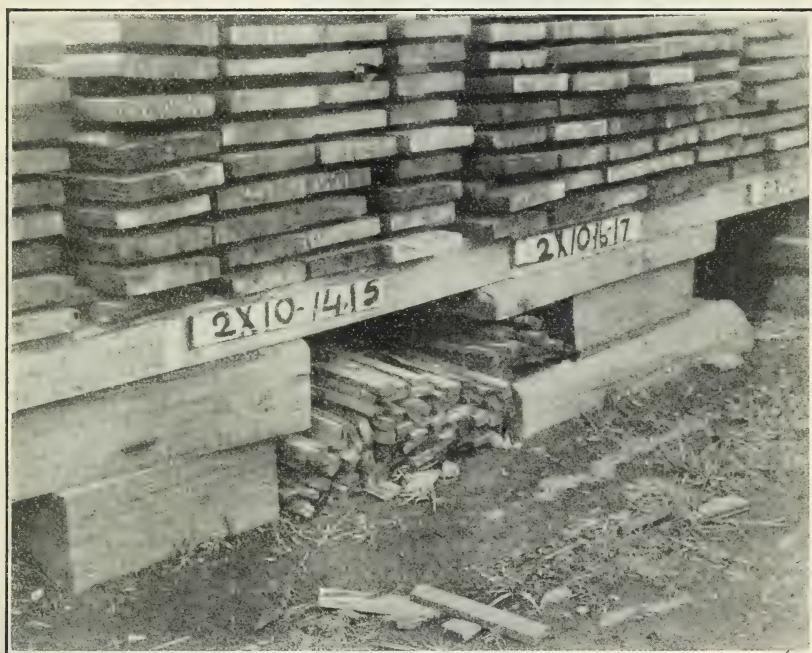
FIG. 25.—Piling sticks placed on wet ground beneath the skids. In order to keep them free from infection, such sticks should never be placed in contact with the soil.

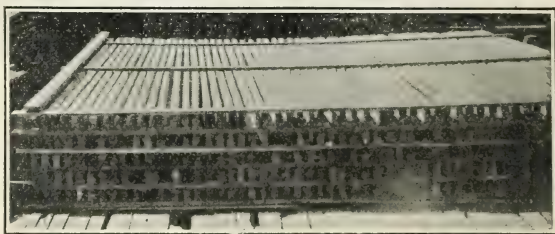
FIG. 27.—Edge-piled 2 by 4 pine at an Arkansas mill. This method of piling permits better vertical air circulation and consequently more rapid drying and less danger from decay during storage.

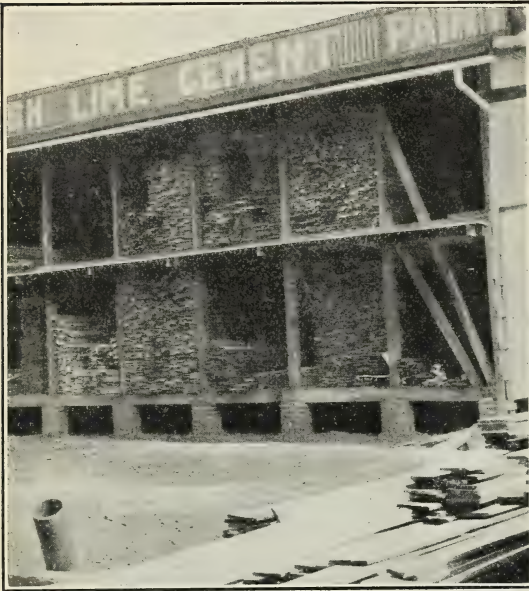
FIG. 31.—A retail shed in Tennessee, well roofed, provided with gutters, and set on brick piers with ample ventilation beneath from all sides.

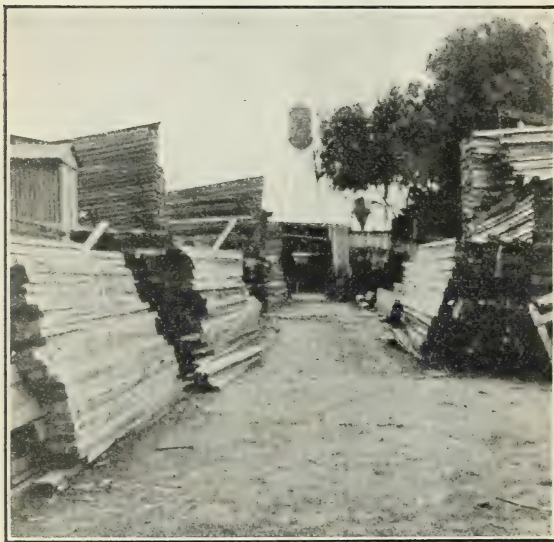
FIG. 33.—A very congested retail yard at New Orleans, La., showing lumber temporarily placed on the ground in solid piles. This is a bad practice, because under such conditions decay may start in a very short time.

On account of very limited storage space, nearly all retail yards fail to observe the proper spacing of lumber to insure ample ventilation. The general tendency is to pile altogether too close to the ground for safety, and in many instances the lumber is not spaced as well in the piles as it should be (fig. 33).

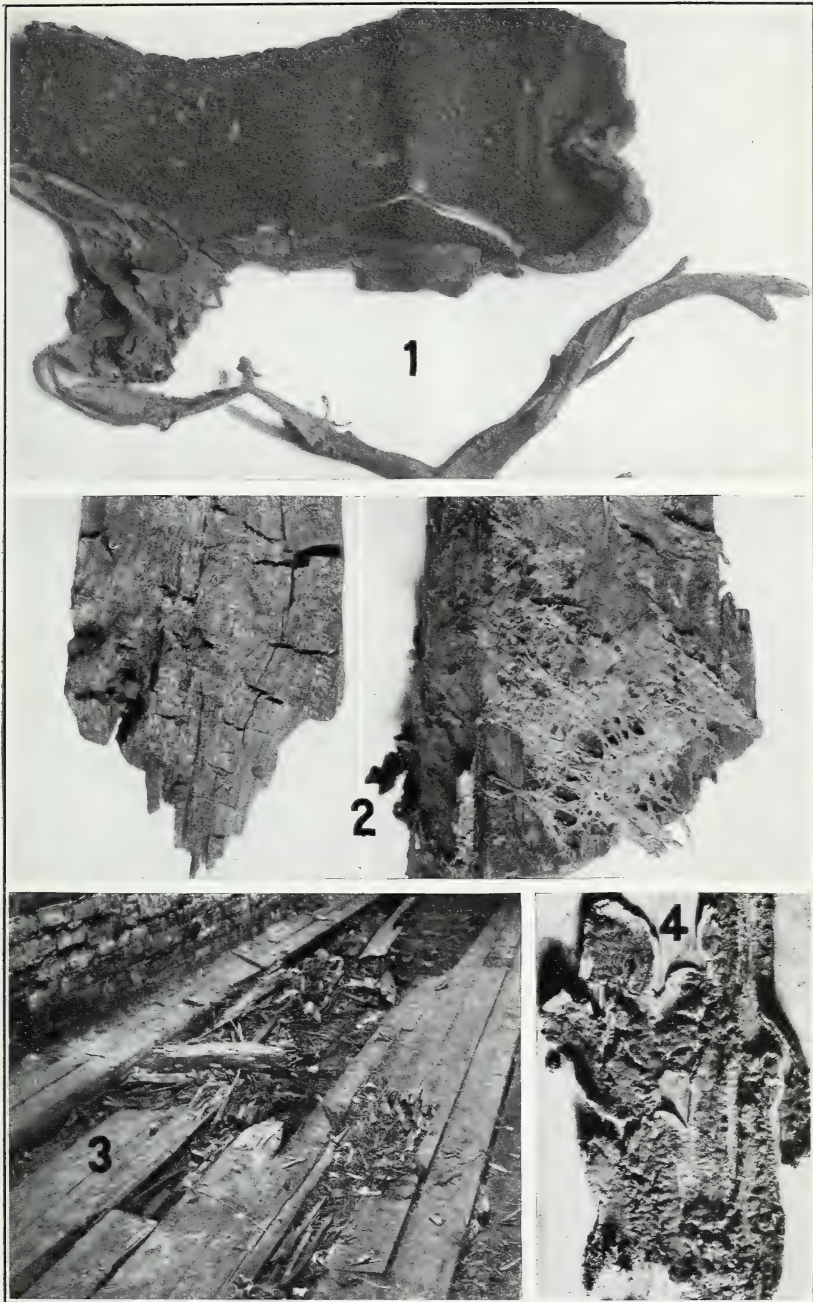
## LUMBER SANITATION: WOOD-ROTTING FUNGI.—IX.

FIGS. 1 and 2.—*Merulius tachrymans*: 1, A well-developed fruit body with porous moisture-conducting strand (from a residence in Pennsylvania); 2, mycelium growing over the surface of the rotten wood. FIGS. 3 and 4.—An unidentified fungus in a Mississippi cotton warehouse; 3, flooring rotted by the organism; 4, fruit bodies developing on other parts of the floor. (This is the same species illustrated in Plate X, figures 1 and 2.)

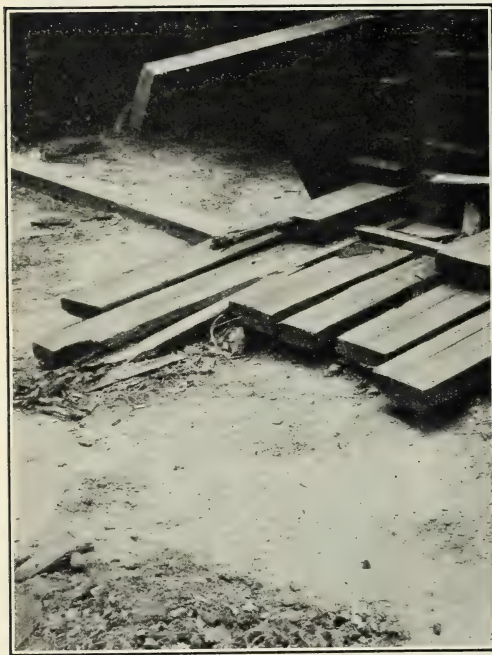
FIG. 35.—Projecting ends of lumber which have decayed by coming in contact with the ground.

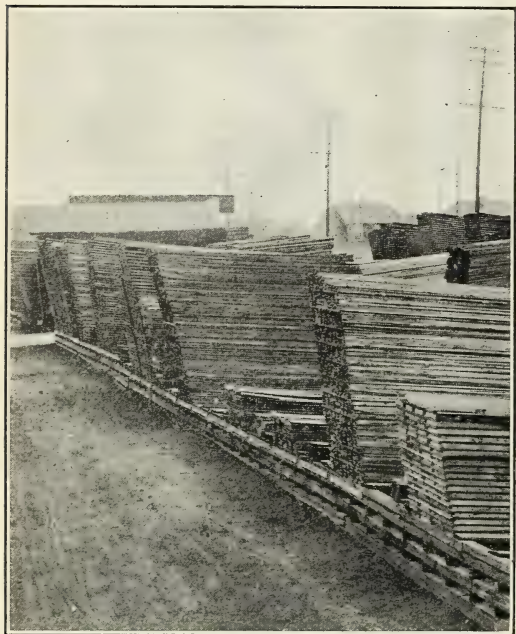
FIG. 37.—The latticed type of built-up plank foundations. This is an improvement over the solid type, as it allows better ventilation beneath the piles.

Many retail lumber yards use solid or latticed foundations of built-up plank running parallel to the alleys (figs. 36 and 37); others resort to wood blocking for the support of the skids. The use of concrete is very limited, but has given complete satisfaction wherever introduced. It is usually laid down as solid foundations parallel to the alleys. In one yard at Birmingham, Ala., the foundations were 8 to 10 inches high, 6 inches thick at the top, and placed in triple parallel rows spaced 7 feet apart (fig. 38). The advantage of reinforcing the concrete is well shown in figure 39.

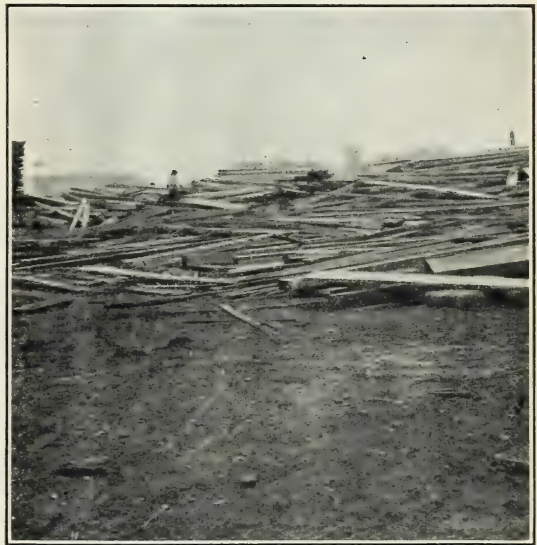
FIG. 40.—A southern retail yard, showing a most insanitary way of handling lumber. Structural timbers should never be thrown promiscuously about on the ground in this manner to become infected with wood-destroying fungi.

is just as evident as in mill yards. The general practice in many of the yards visited is to throw sticks about on the ground when the stacks are torn down, and there they often remain until they are needed again. This insanitary practice needs no further comment. A comparison of the yard shown in figure 40, where the lumber is scattered about promiscuously on the ground, with the yard shown in figure 15, where concrete foundations and treated ties are in use and all débris is carefully
